Product Note **VR2510**

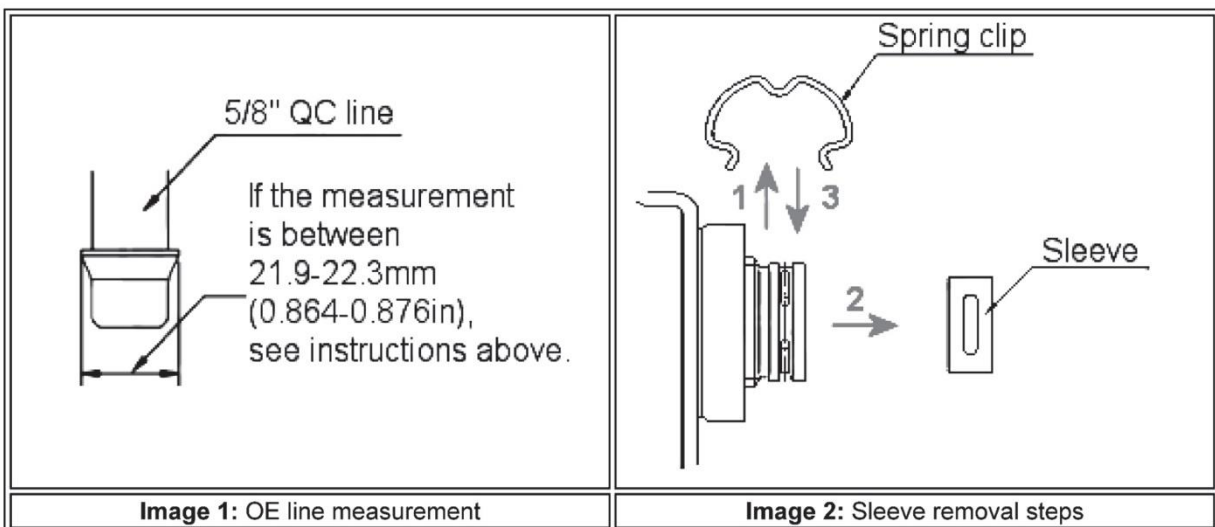
The transmission oil cooler (TOC) fittings (located on the passenger-side tank) on the VR2510 radiator may require modification if the lines will not install into the fitting; or the diameter at the widest point of the flared end of lines measures 21.9mm – 22.3mm (0.864in – 0.876in) [image 1]. In order to allow the lines on the vehicle to install into the fitting, remove the fitting sleeve as follows [image 2]:

1. Remove the spring clip from the fitting using a pick or pointed tool by gently prying one end out of the fitting and rotating the spring away from the fitting. Take care to not damage it. Save the clip as it will need to be reinstalled later.
2. Slide the sleeve out of the fitting.
3. Reinstall the spring clip in reverse of how it was removed.
4. Install the line in the fitting. Listen for a “click” (indicating the spring clip has snapped behind the flare on the line).
5. Check that the line is secure in the fitting and cannot be pulled out.
6. Repeat for the other fitting and check for leaks.
